3. INTERMEDIATE FIELD TEST 1

3.1 TEST 1 OBJECTIVES AND TEST PIT OVERVIEW

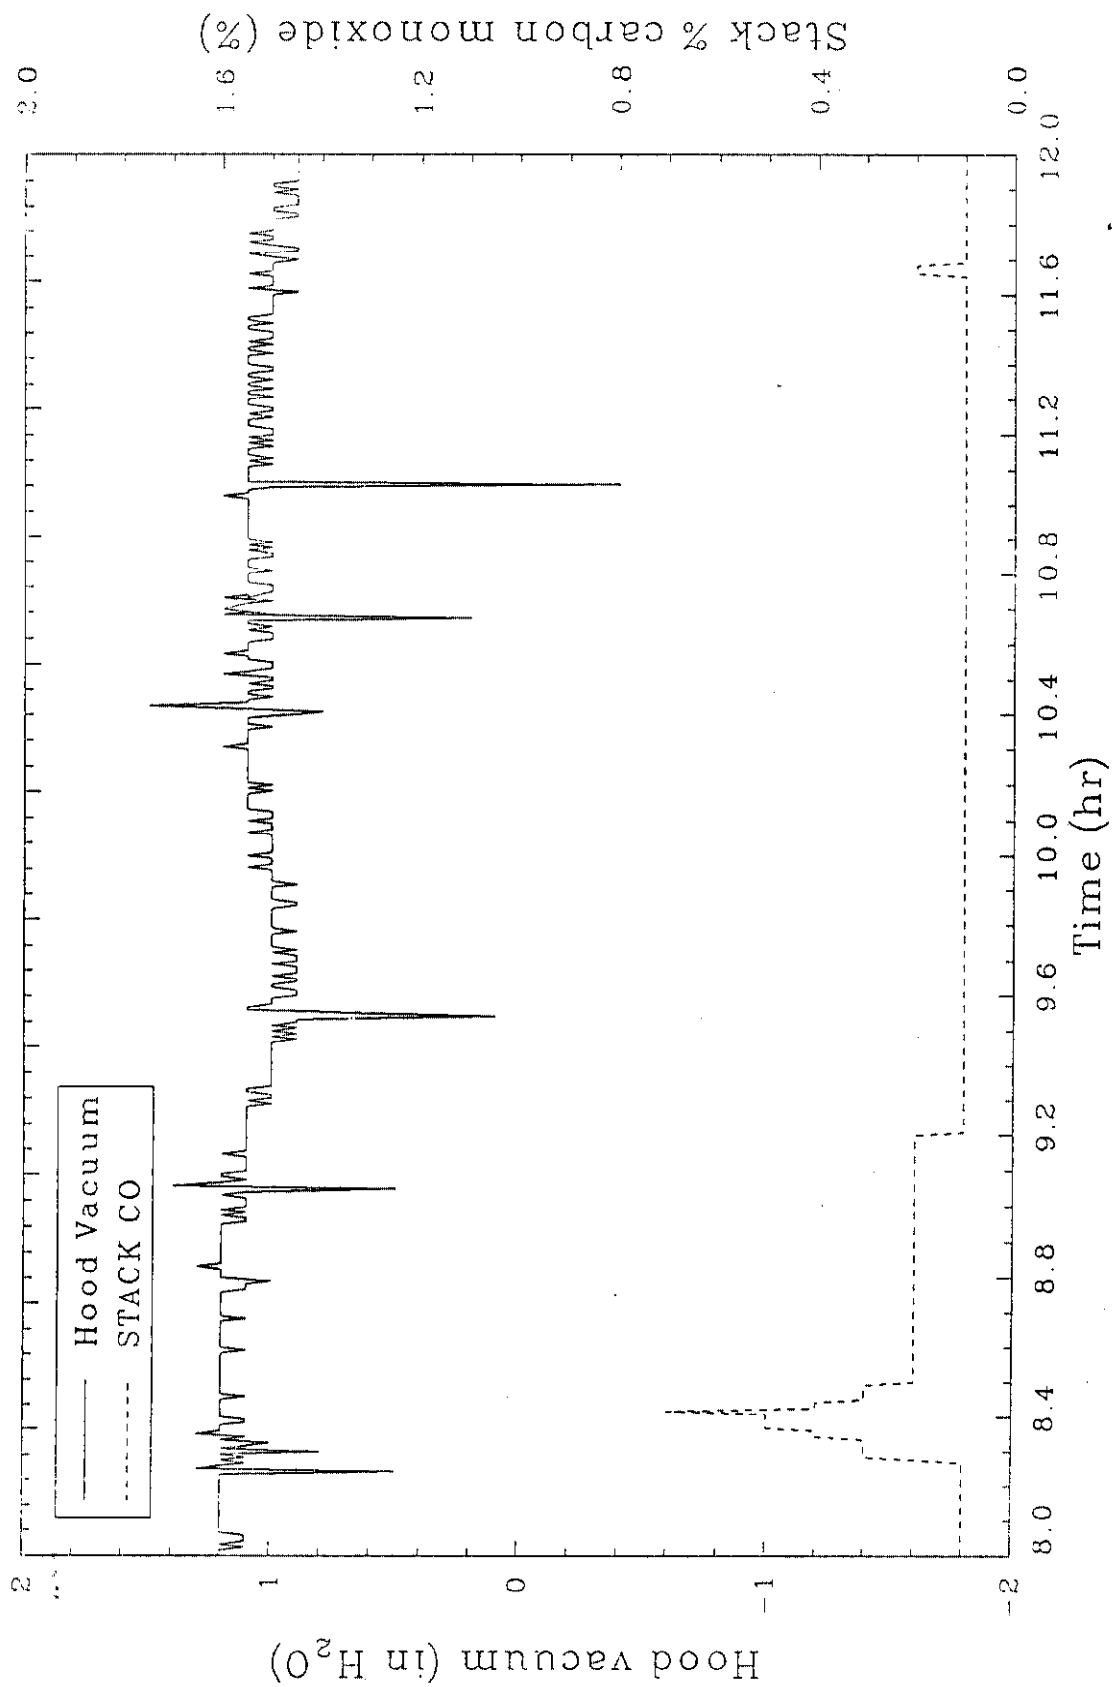
as the graphite starter path is consumed. Several pressure spikes resulted in a slight decrease in the oxygen concentration but were not accompanied by increases in carbon monoxide, as shown in Figure 33. It follows that the gas release from the melt in those cases was due to a release of steam or other noncombustible gas from a container, such as the noncombustible sludge cans that contained water. This phenomenon is explained by the release of noncombustible gasses from the melt, such as steam effectively displacing or decreasing the quantity of air entering the hood.

Figure 33. Hood vacuum and stack carbon monoxide concentration for Test 1, showing pressure events not concurrent with CO spikes.

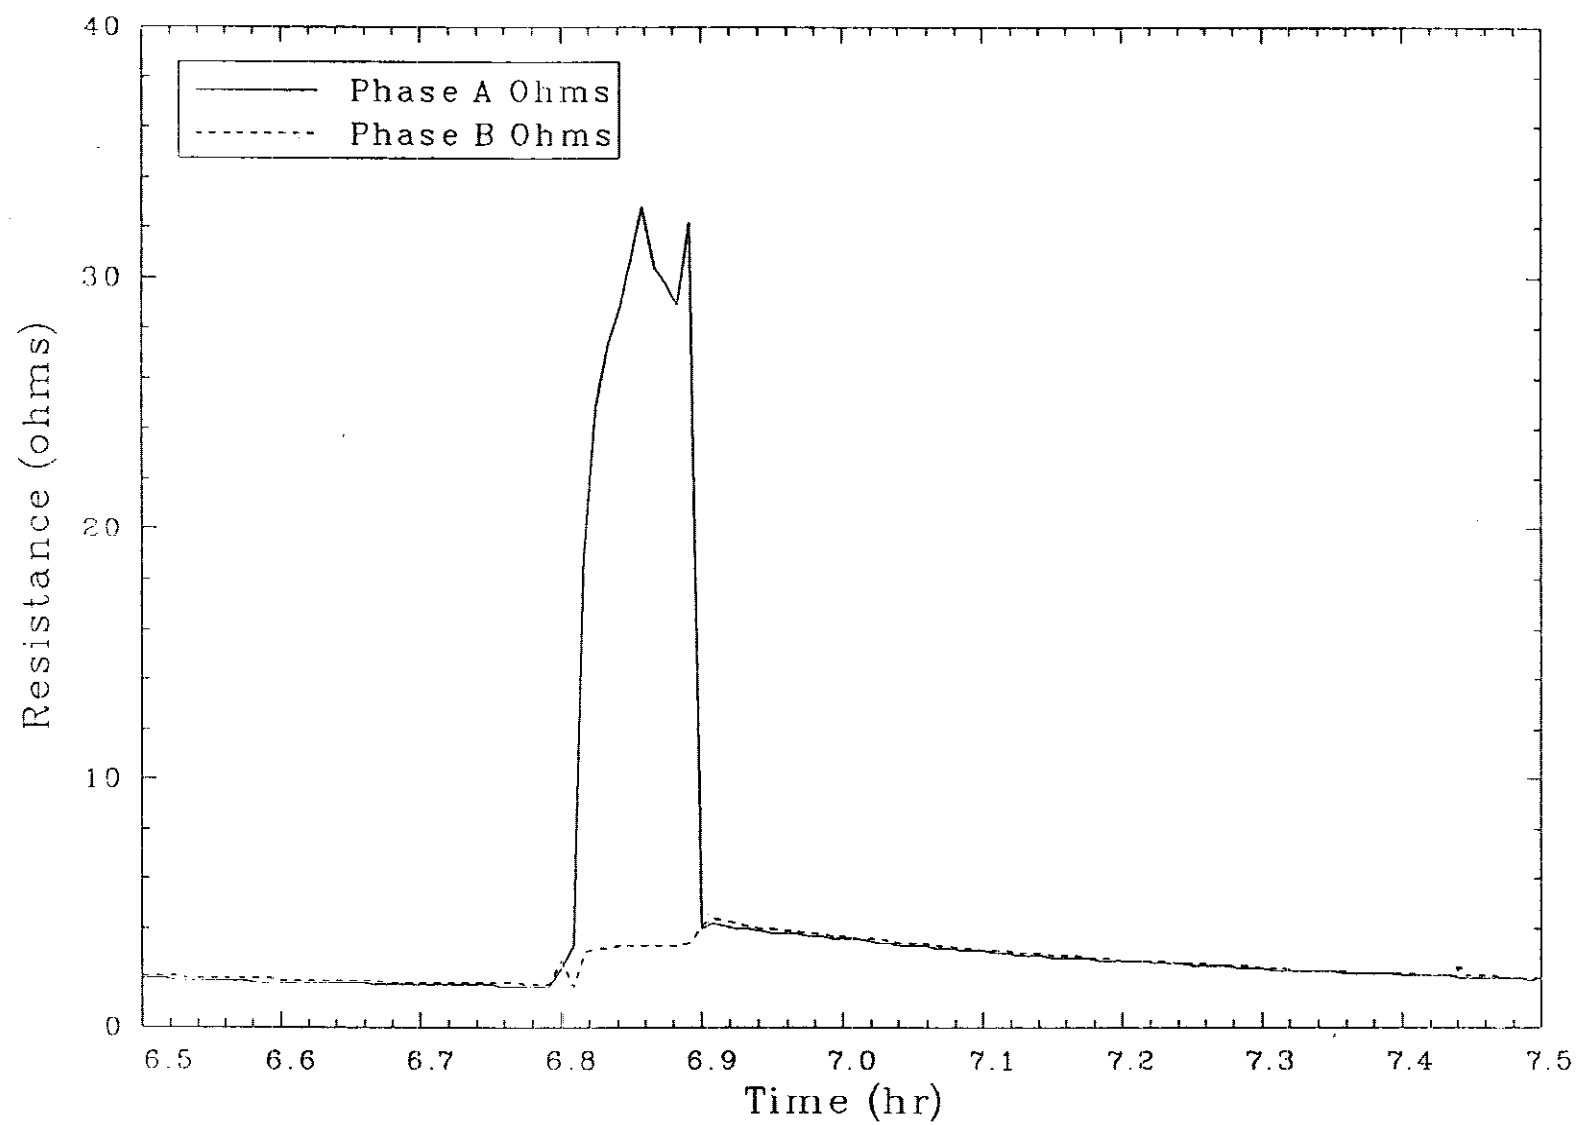
Electrical resistance data from this event are similar to the initial event. Phase A ohms increased from 2 to approximately 33 ohms while phase B increased from 2 to 5 ohms, as shown in Figure 41. Phase A amperage decreased from approximately 400 to 160 A, as shown in Figure 42. Figure 43 illustrates the total power of the test decreasing from 440 to 180 kW as a result of the event. Even when accounting for a nonpowered period of operation immediately following the pressurization, phase A resistance dramatically increased, while phase B resistance increased only moderately. This again suggests a localized effect on one of the two phase A electrodes.

Figure 41. Phases A and B resistance during the second event in Test 1.

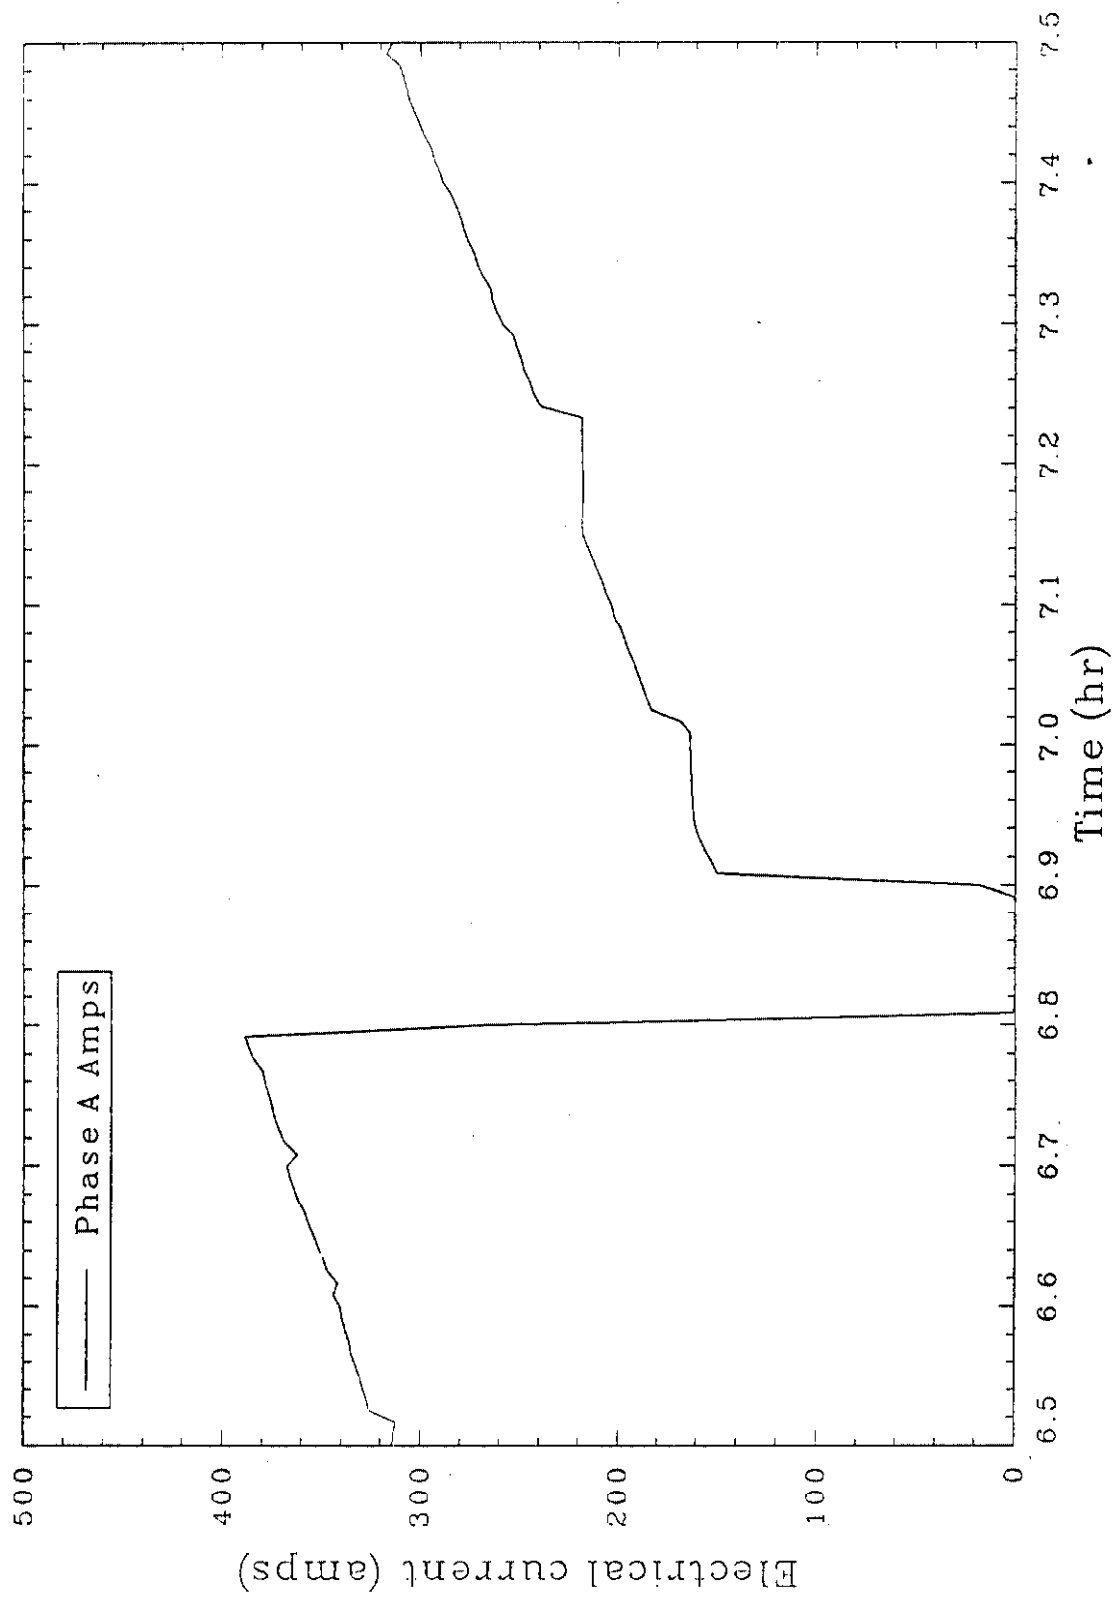
Figure 42. Phase A amperage during the second event in Test 1.

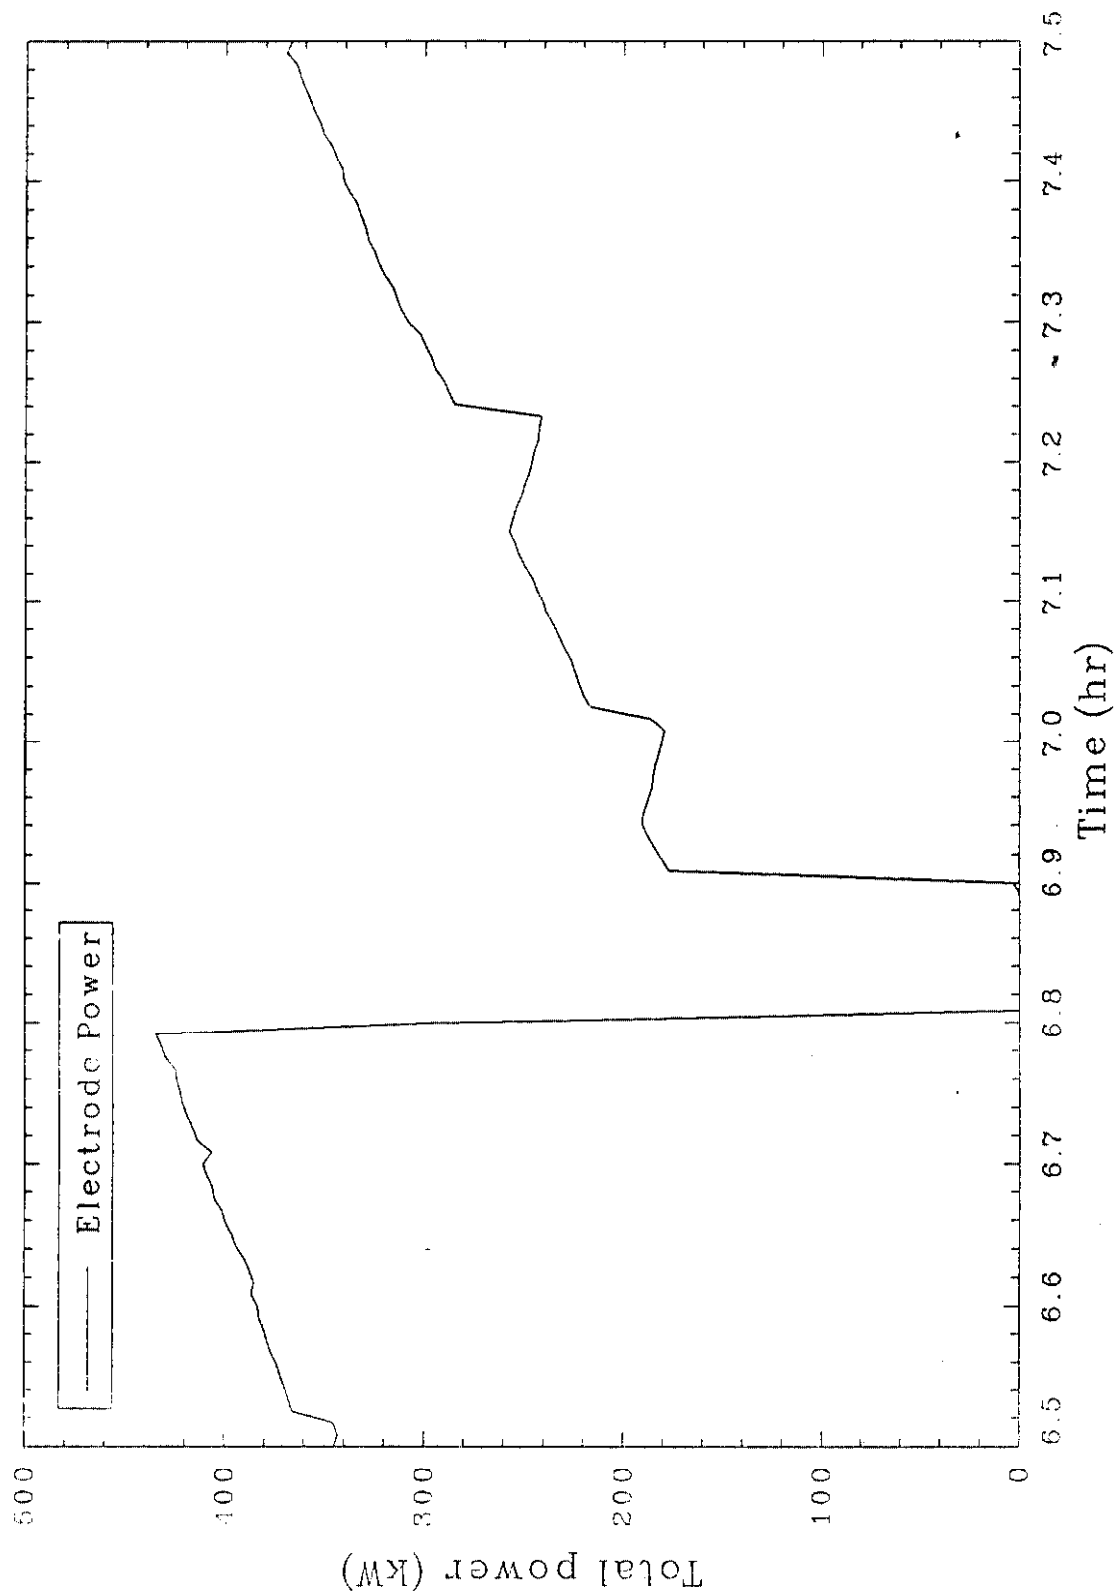
Figure 43. Total electrode power during the second event in Test 1.
